FY2016 4<sup>TH</sup> QUARTER INL/EXT-16-40166

IDAHO NATIONAL LABORATORY

QUARTERLY
OCCURRENCE
ANALYSIS

DEEPER LEARNING THROUGH
EVENT ANALYSIS

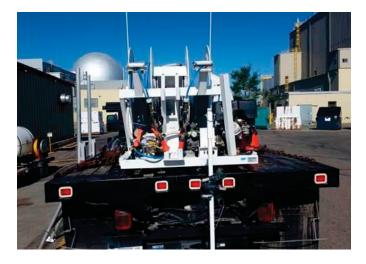
Two INL workers were sprayed with herbicide from a spray truck after the boom portion of the system was removed from service and the hose and solenoid valve removed. This portion of the system was isolated by a ball valve and had a 90-degree elbow installed at the end of the piping.

While performing on-the-job training, a qualified herbicide applicator inadvertently opened the ball valve that was isolating the removed piping. The action resulted in the qualified applicator and a trainee being sprayed with herbicide. Both personnel immediately flushed their eyes and face, reported to medical, and showered. They were released back to work with no restrictions.

- The spray truck was used with part of the spray system out of service. There was not a formal evaluation on possible hazards and mitigations prior to using the truck in the current configuration.
- Time pressure was a factor in the event. The weather
  was nice with little wind and presented an ideal situation
  for spraying weeds. The parts to repair the spray system
  had been ordered but had not arrived; however,
  personnel decided to proceed in spite of the
  configuration of the truck.

Following the event the elbow was removed and a plug installed at the ball valve to prevent this from happening again if the equipment had to be used before maintenance was complete.

- Careful consideration should be made prior to putting equipment back in service when it cannot be operated as designed. Management and safety personnel should be involved to ensure use of the equipment is appropriate, necessary, and all hazards have been identified and mitigated.
- Due to changes in the configuration of the sprayer mechanism, a single point of failure was present that allowed the workers to be exposed to the chemical with only one irrecoverable action. Defense in depth was not present.

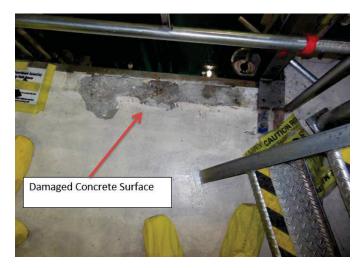
At the ATR the 2-Ton main floor crane was being used to remove the Test Train Assembly Station (TTAS) from the canal. During the lift of the TTAS, it became bound/caught on the test assembly storage rack (hereafter referred to as the storage rack), which was used to store the TTAS in the canal. An upward force was applied to the storage rack when the TTAS was being removed and caught an edge which caused three anchors in the top of the storage rack to pull out of the concrete. The three concrete anchors that failed were used to secure the storage rack in place along the top surface of the working section of the canal.

The storage rack assembly was extensively inspected by ATR Quality Assurance inspectors by means of visual and liquid penetrant examination and no relevant indications or damage was identified. There was no degradation of condition to storage rack assembly. The 2-ton crane was also inspected, and no damage was observed.

This operation had previously been performed under similar work control, but the design engineer, who was typically present during normal work evolutions, was not available.

A plan was developed to remove the TTAS from the canal then place the 2-ton crane out of service pending inspections, stabilize the storage rack using rigging slings and tie off to available structure, move a non-fissile test stored on the storage rack to another location in the canal, and declare the storage rack out of service for inspection and repair.

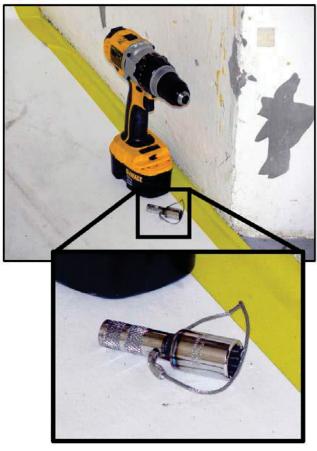
On June 6, 2016, a worker at the ATR was injured while conducting maintenance on the South Safety Rod Drive (SRD) package. A cordless 18 volt ½ inch drive drill with an adapter consisting of a shortened extension bar welded to a ½ inch socket was used to operate the SRD Pole Hoist to lower the SRD package to the floor. The adapter had been modified to accept a wire loop lanyard (approximately a 3 inch diameter) through the extension bar shaft. The lanyard was added so the adapter could be hung from the pole hoist in an effort not to lose it. This wire lanyard introduced an entrapment hazard on rotating equipment that was not identified or mitigated.

finger of the left hand, which resulted in a partial amputation of the finger.

Two of these adapters have been in service since approximately 2010. The preferred method when performing work is to locate the appropriate tool for the job, including purchasing if necessary. When it becomes necessary to develop or modify a tool to solve a situation that arises when conducting a task the employee should ensure that it is evaluated and approved to ensure hazards are fully mitigated.

- Management did not ensure the risks and hazards introduced through the modification to the socket were adequately reviewed and assessed. As a result, the hazards were not mitigated in accordance with the hazard mitigation hierarchy contained in LRD-14001, "Occupational Safety and Health Program."

- There are no INL procedures that direct how and when a tool can be modified. As such, tool modifications may not receive the proper review, analysis, and approval, which may result in unmitigated hazards being introduced into the workplace. If the crafts are using standard hand tools to perform work, INL work planners are relying on skill-of-the craft to identify and mitigate hazards, but when tools are fabricated, the modified tools are not necessarily assessed and the hazards associated with them mitigated.

- Many employees identified the impact hazard (being stuck by the wire lanyard as it rotated) but did not recognize the greater entanglement hazard and as such, they failed to take action to remove the hazard.
   Employees noted that they were aware of the impact hazard and performed their own hazard mitigation by keeping their distance from the lanyard.

Following the event, ATR Maintenance Management directed that the steel cable lanyards on the SRD Pole Hoist adapters be removed to eliminate the hazard associated with the rotating equipment. As discovered during the critique, Maintenance and Construction personnel have a tendency to modify manufactured tools to meet a usage need during repair or construction work. An example of such a modification would be shortening of an open ended wrench to fit within a restricted area to install or tighten nuts. This practice of modifying equipment and tools should be evaluated at INL to see if other unmitigated hazards have been introduced to the workplace.

- Attention to Detail Additional attention is needed when working with rotating tools/equipment.
- Hazard Identification Equipment must be used per manufacturer's instructions and be maintained in a safe condition. When modifications are needed, they must be evaluated, and approved to ensure hazards are fully mitigated.
